Manhole Inspection Summary

Manhole # S37QQ_019MH

Insp Date: **1/16/07 9:39 AM**

Location Address: **2522 GREENMOUNT AVE**

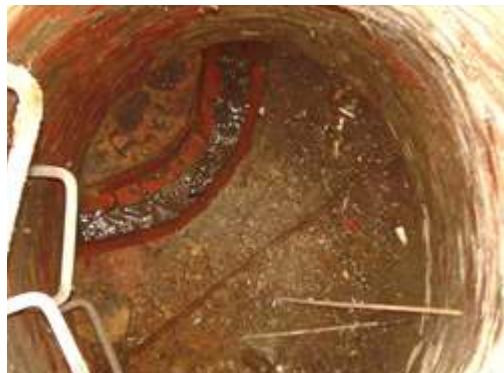
Top View

Corroded steps. Evidence of surcharge - Bench debris. Channel debris.

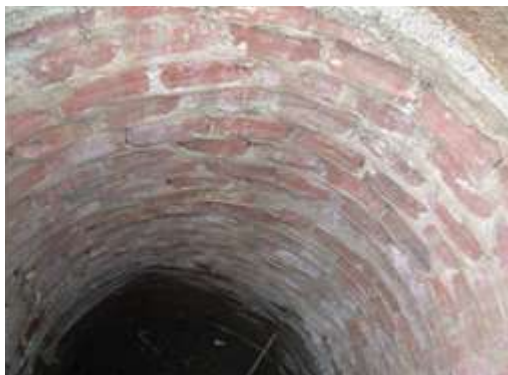
Defect

Frame leaks. Adjustment and Barrel infiltration.

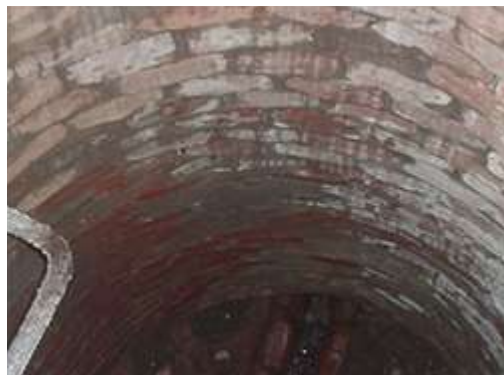
Defect

Adjustment, Corbel and Barrel infiltration.

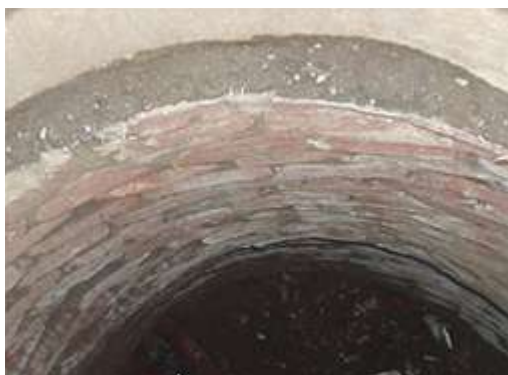
Defect

Frame leaks. Frame offset. Adjustment, Corbel and Barrel infiltration.

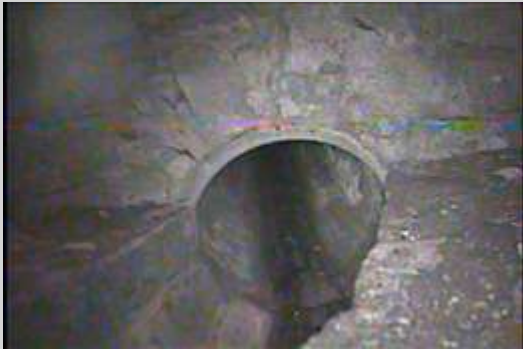
Pipe Out @ 12 O'Clock

Pipe Material: **Clay** ☐ Pipe Lined

Invert Depth: **9.65** (ft.) Flow Characteristics: **Slow**

Infiltration: **None** Pipe Seal Cond: **Sound**

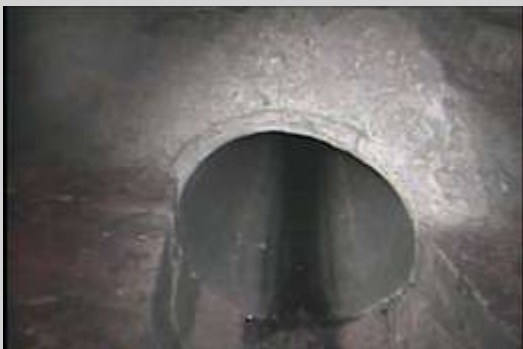
Pipe In @ 9 O'Clock

Pipe Material: **Clay** ☐ Pipe Lined

Invert Depth: **9.35** (ft.) Flow Characteristics: **Slow**

Infiltration: **None** Pipe Seal Cond: **Sound**
